CHC HOME INSPECTION  
(800) 975-0275  
info.chcinspection@gmail.com  
<https://www.chchomeinspection.com/>

## INSPECTION REPORT

Subject Address  
Lexington, KY

Inspector  
**James Sanders**  
KY Licensed Home Inspector, #276294  
(800) 975-0275  
admin@chcinsp.com

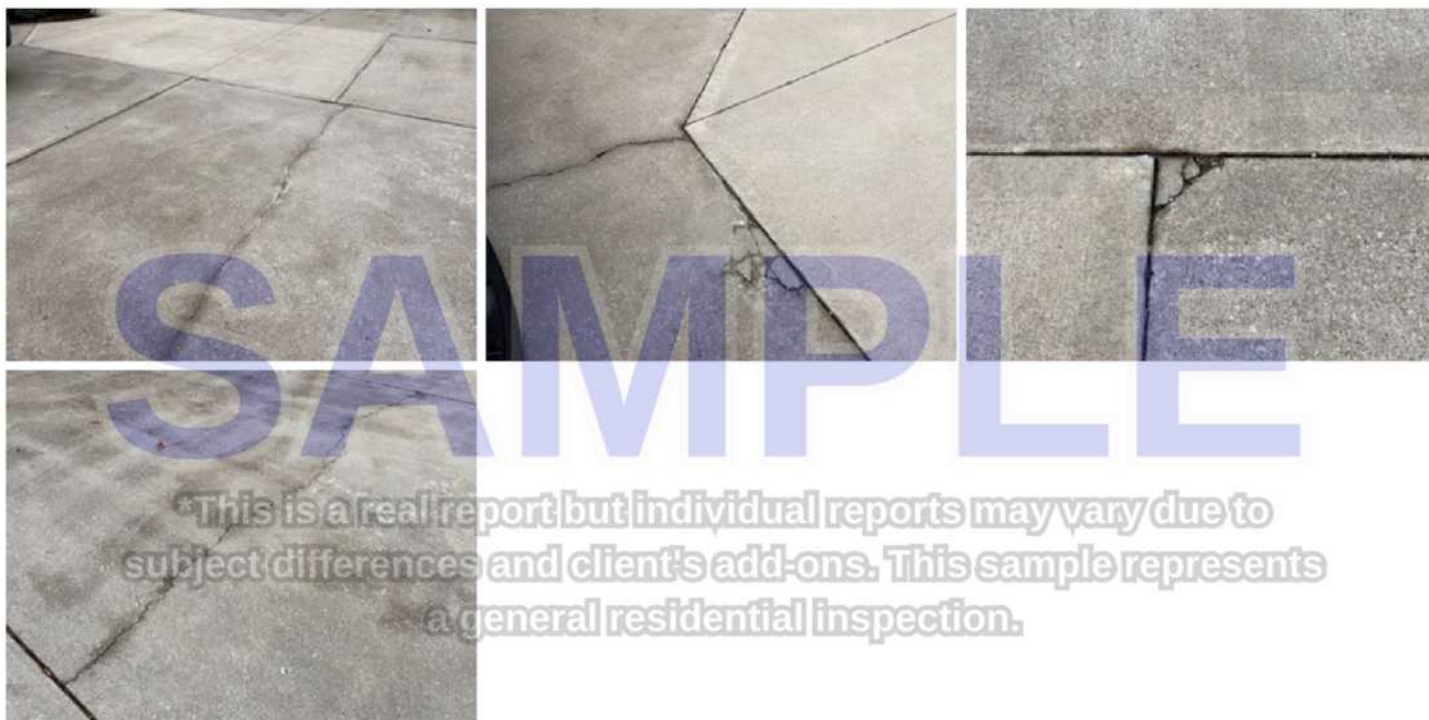
FYI: Spalling is a concrete surface condition where the top layer of concrete is failing to remain intact and is present at the concrete driveway. Commonly a result from a high water/cement ratio at time of concrete placement. Can also be caused by the use of de-icing salts/ chemicals in winter conditions. Monitoring and/or maintenance is recommended of these areas to ensure condition does not deteriorate to a point of becoming a tripping hazard.

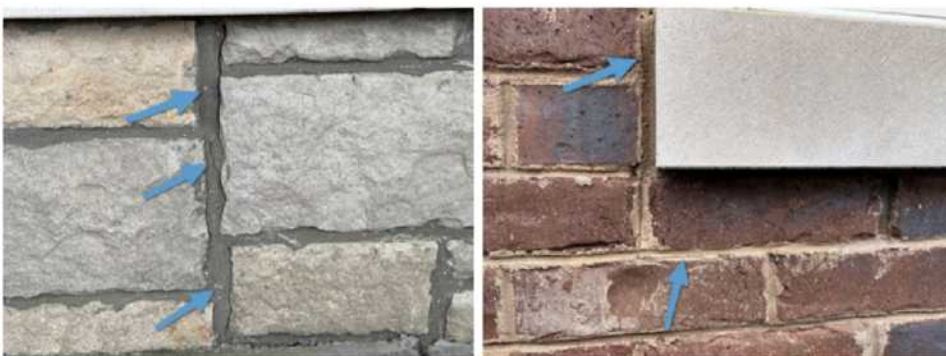
Masonry veneer has some cracking where noted. This is considered typical cracking which could have derived from foundation settlement, material expansion and/or steel lintel expansion. You will also notice these cracks will typically appear from the corners of window and door openings which is the path of least resistance. Concerns with the foundation below this area will be addressed in the structural section of the report if any is present and/or if foundation is visible during this inspection. Recommend keeping any cracks/openings of the veneer tuckpointed as needed. If any further/future movement is noticed, then further invasive evaluation of the areas below this veneer is recommended.

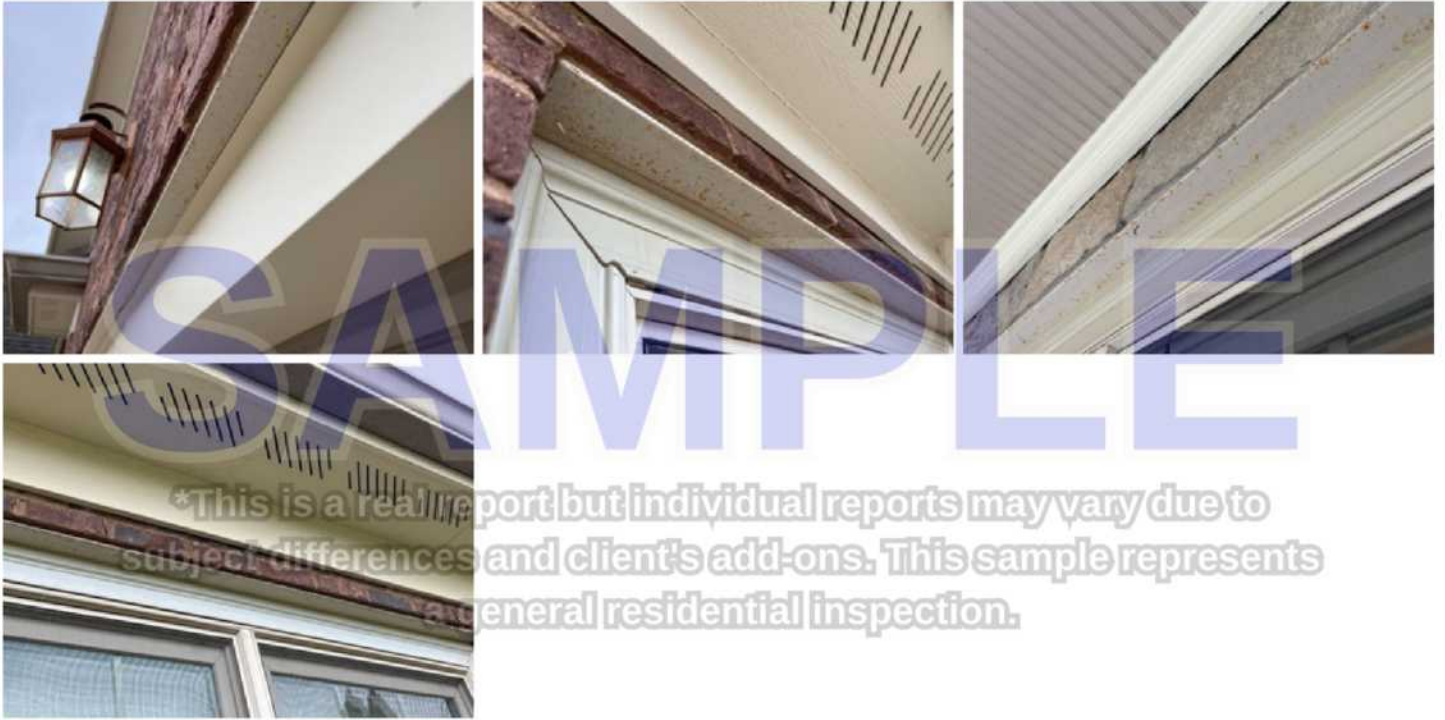
Rusting is present at the steel lintels where noted. It is recommended to maintain these lintels with a rust prohibitive coating/sealant.

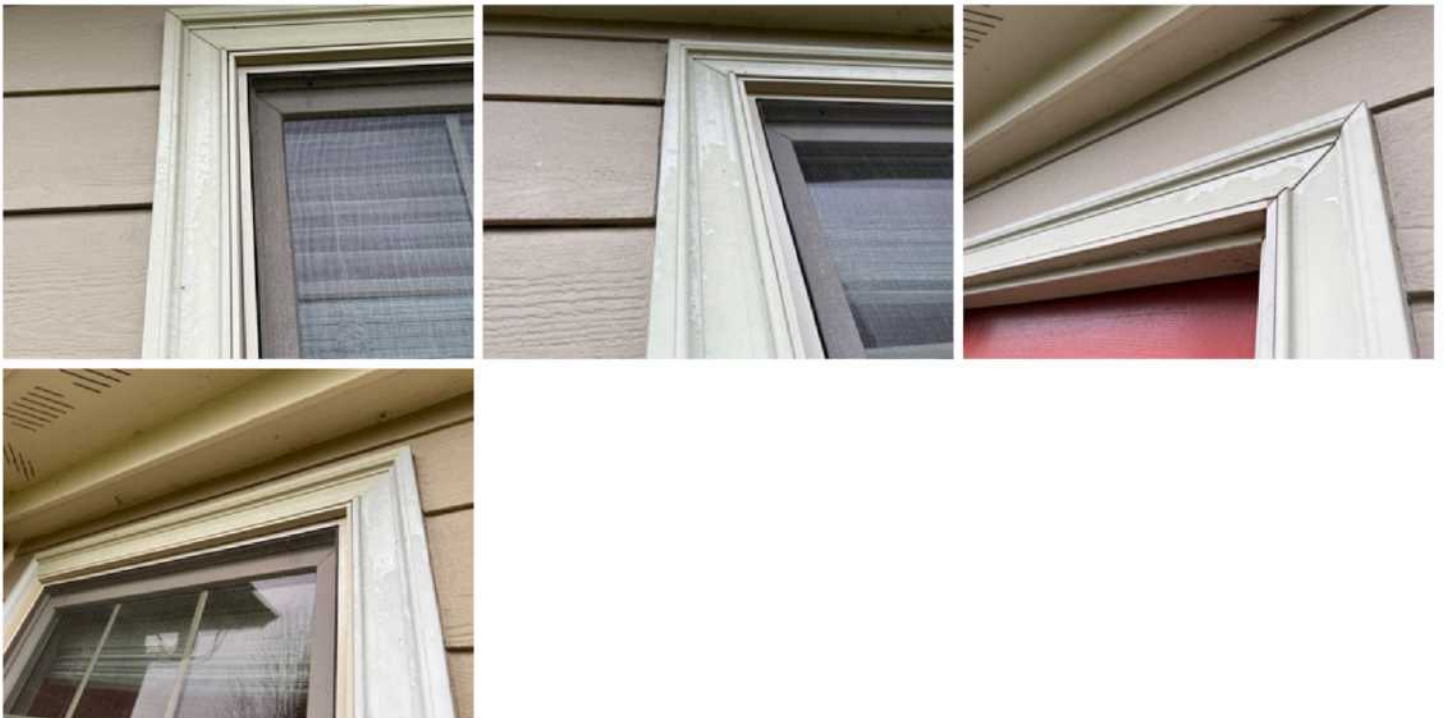
3.3.1 Soffit, Fascia, Rakes, Trim, Accessories

Trim where noted is weathered and/or has a peeling paint finish. Proper maintenance is recommended. Keep in mind, some of these areas could have decay that is not easily accessible or visible during this inspection. Any areas with decay are recommended to be properly repaired and water source remedied if still present.

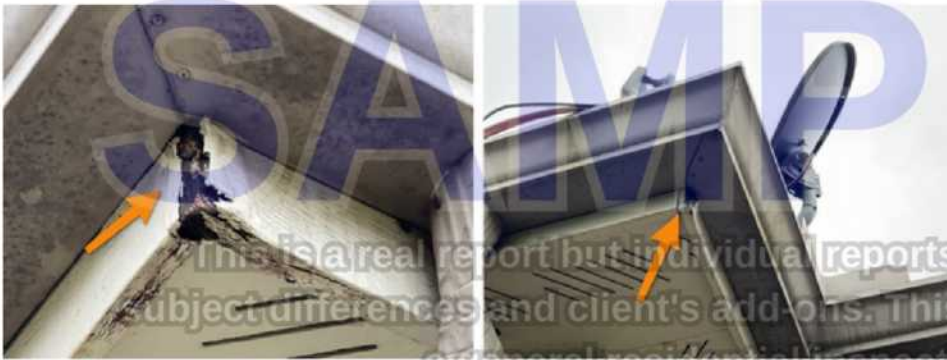
3.3.2 Soffit, Fascia, Rakes, Trim, Accessories

Some decay/damage is present where noted. Recommend proper repair and further protection to reduce risk of further damage to the trim and beyond.

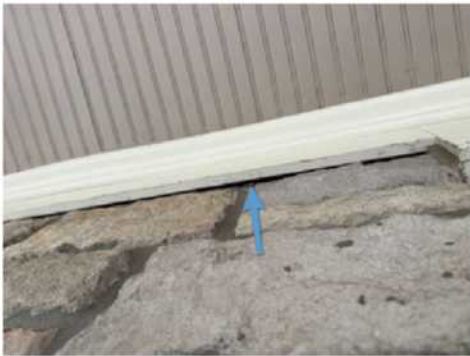
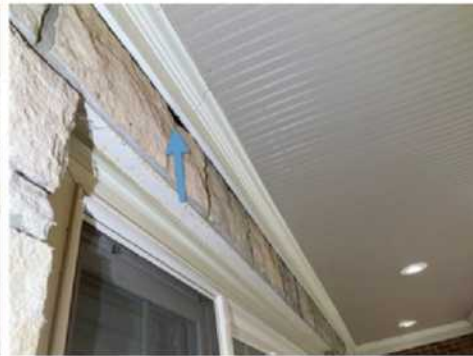
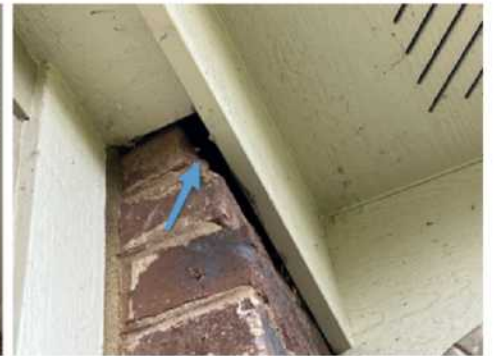
Gaps in or at the exterior trim is present where noted. Recommend keeping sealed any exterior gaps to reduce the risk of moisture penetration to beyond the exterior siding/veneers/trim.

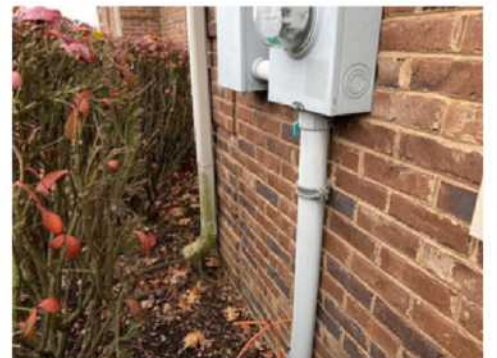
3.4.1 Downspouts / Extensions

Downspout is depositing directly adjacent to the foundation where noted. Extensions are recommended to be added to move storm water discharge point away from the house and into an area of positive drainage. Splash-blocks often do not remain in place or extend far enough to have a positive impact. Downspouts allowed to discharge adjacent to the house may allow excessive storm water to reach the foundation of the house where adverse effects can develop.

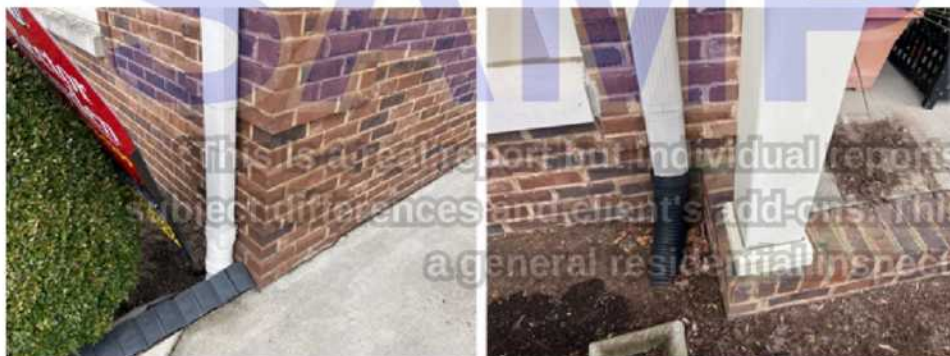
## 3.4.2 Downspouts / Extensions

Downspouts are directed into underground drains/extensions where noted. It is recommended to locate where these drains run to daylight and maintain to keep free of blockages for proper drainage away from the house/foundation. As long as a positive slope is present in the adjacent grade, it is considered an improvement to have the extensions above grade and not below grade for ease of monitoring/maintenance.

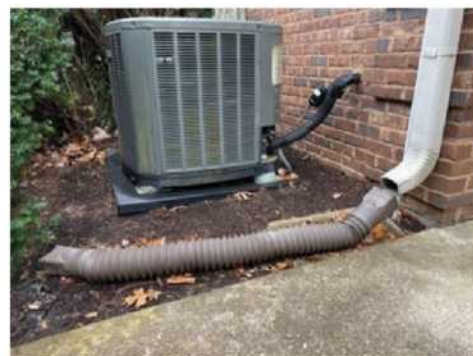
## 3.4.3 Downspouts / Extensions

Extension is currently disconnected where noted. This often occurs as the ground around the extension settles and pulls on the extension. This increases the risk of spilling storm water draining from this downspout at or adjacent to the house. Recommend repair or improvement to ensure storm water is properly transferred away from the house.

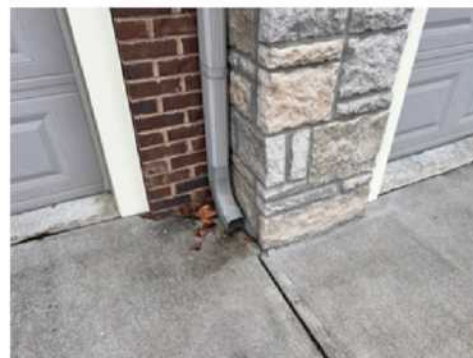
## 3.4.4 Downspouts / Extensions

Recommend keeping any gaps or construction joints around the downspout location properly sealed. Also keep in mind, anywhere a downspout runs overtop of hard surfaces such as sidewalks, patios, driveways, ect. these areas will often be slick in colder weather as well.

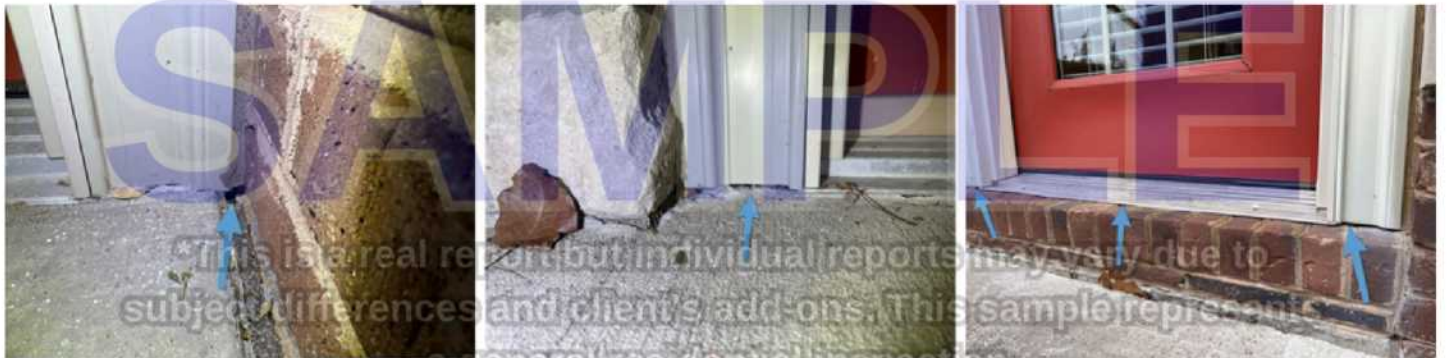
## 3.6.1 Entry Doors

Door openings have separated or missing sealant where noted. Proper sealing is recommended to prevent storm water from gaining access to the wall sheathing/framing beyond.

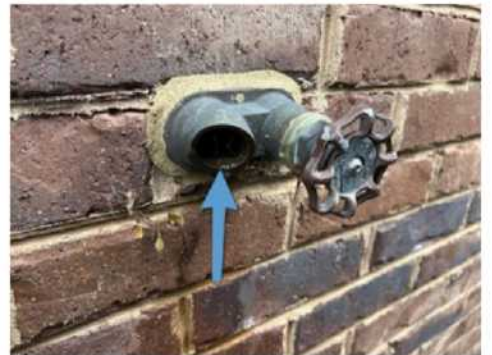
Hose bib where noted is incomplete/missing aerator. Recommend repair/replacement as needed to return to a proper operating condition.

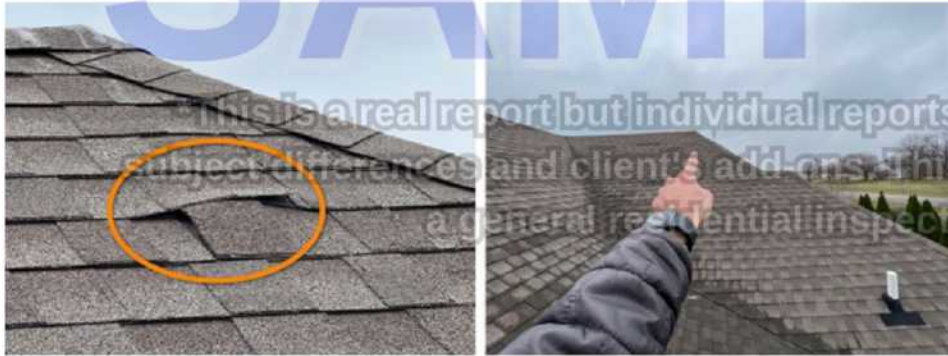
Raised nails/fasteners observed on roof. Recommend re-seating to secure and so the above shingle tab can lay flat on roof. Any opening made by the roof nail to the shingle above is recommended to be repaired.

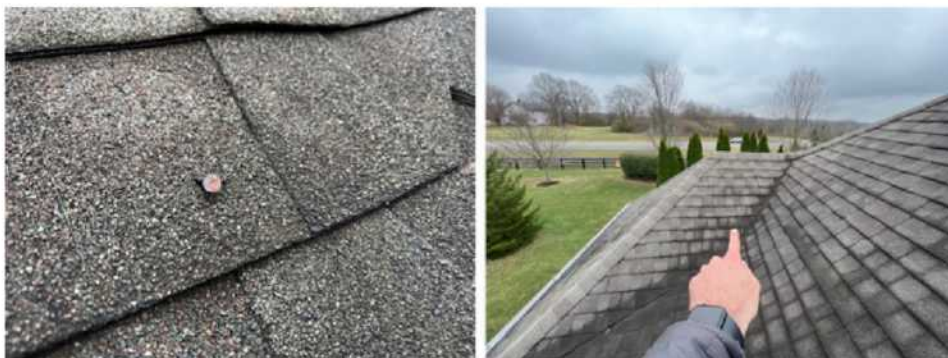
## 4.1.3 Shingles

Raised nails are visible where noted, that have punched through the above shingle. Repair is recommended of these locations. Whoever is performing the repair, should be thorough in looking for this condition during the repair, as this inspection may not have noticed all locations at time of the inspection.

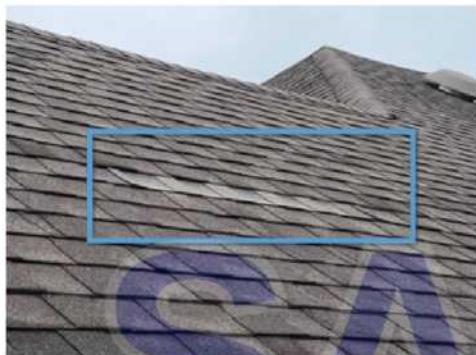
## 4.1.4 Shingles

FYI: Newer shingles have been installed where noted. Recommend questioning seller about this location to determine extent and reason for repairs.

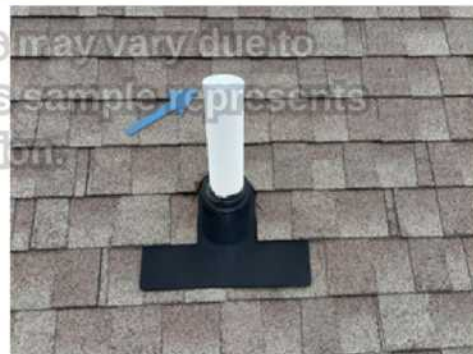
Plumbing vent still has the test cap in place from time of construction. Plumbing vents are installed in the system to allow proper drainage. It is important that this vent be open. Reduced or slower drainage flow may be present within the home when the vent is obstructed. Recommend removal of this cap.

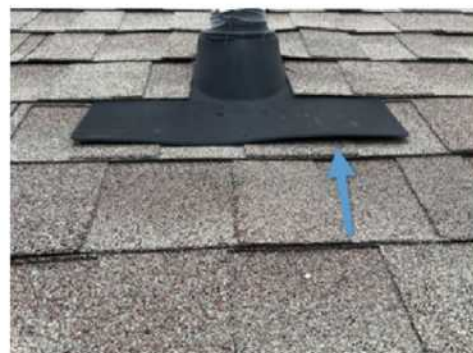
#### 4.4.2 Roof Penetrations / Openings

Roof boot flashing is not properly secured / sealed at roof penetration where noted. Improvement is recommended to reduce risk of storm water penetration.

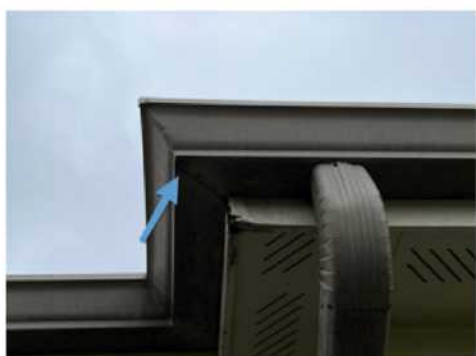
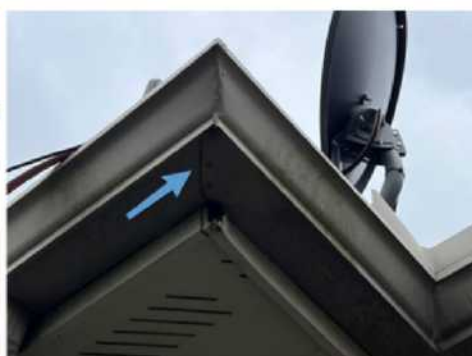
#### 4.5.1 Gutters

Gutters were observed to be leaking in one or more areas. Recommend a qualified contractor evaluate and improve gutters to prevent leakage and properly transfer storm water to the downspouts.

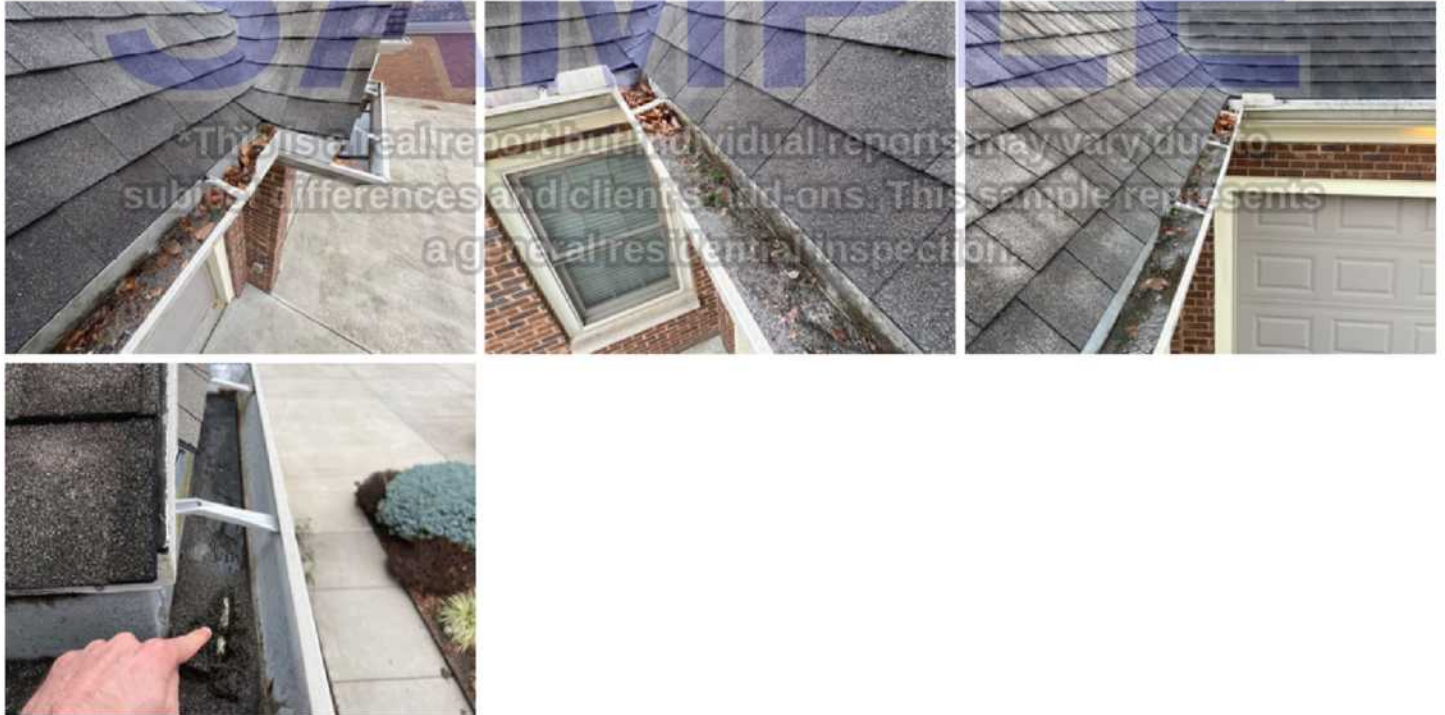
4.5.2 Gutters

Debris is present in the gutters where noted. Recommend cleaning of the gutters and verification of proper drainage to the downspouts once gutters are cleaned. Often the weight of moderate debris can weigh down the gutters and create sagging which could hold water and prevent proper drainage.

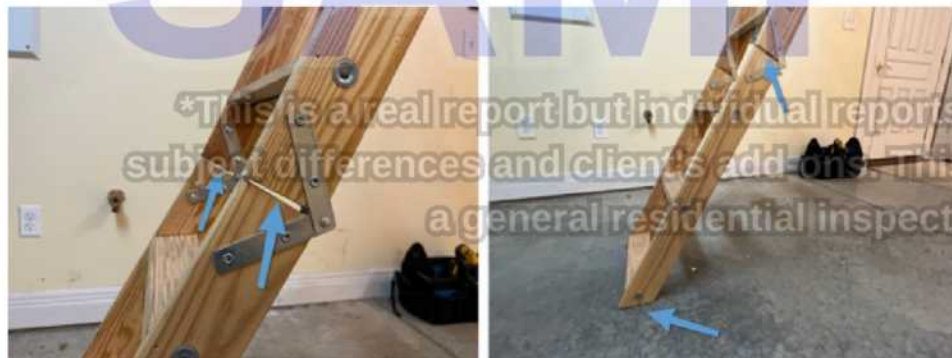
Access ladder has not been trimmed for a proper fit at the door. It is recommended to trim the ladder in a way that is acceptable with the manufacturer's use and extension of the ladder. Full strength of the ladder may not be obtainable in current state.

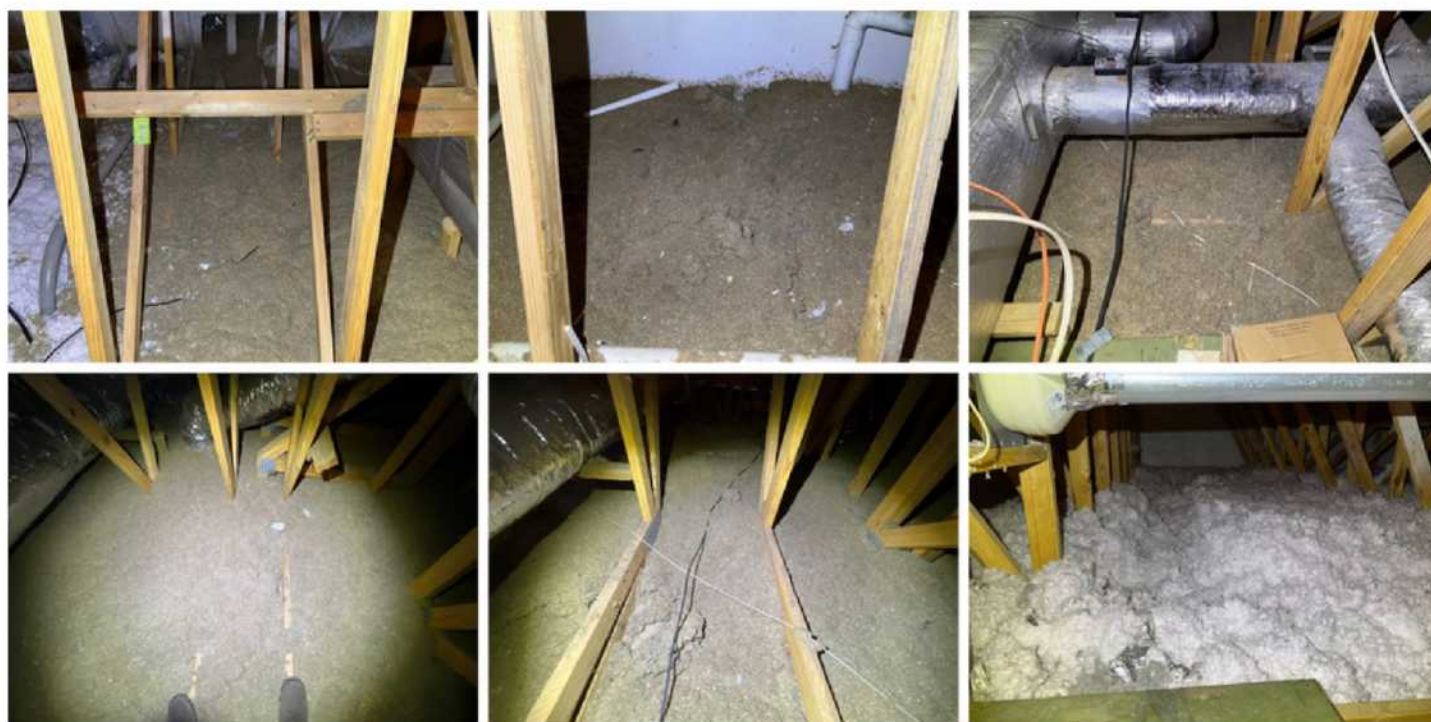
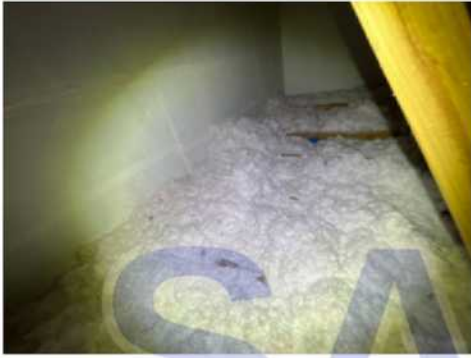
Insulation has been disturbed/compressed where noted. This creates a reduced R-value where disturbed. Spot filling or reinstallation as needed to bring the insulation depth or coverage back to an appropriate depth is recommended.

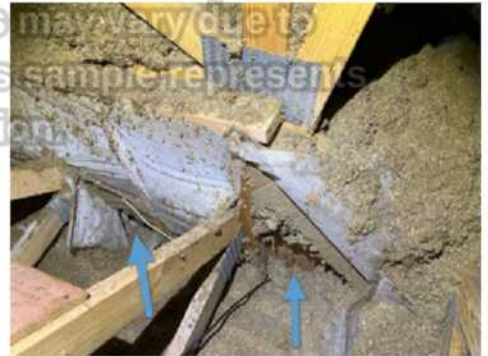
Vertical locations in the attic are insulated but some of this insulation has fallen or is missing. Recommend correction to ensure a complete thermal barrier. Proper installation requires the insulation be in contact with the back side of the finished surface.

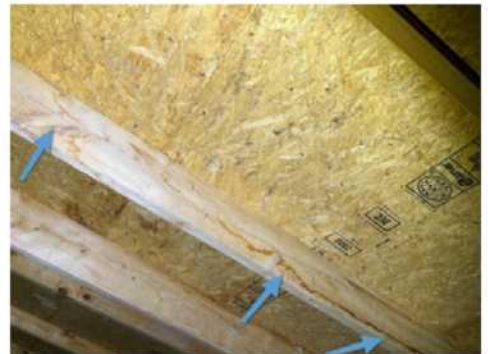
## 5.5.1 Moisture Penetration

Moisture staining is evident and visible within the attic where noted. This inspection cannot confirm if this is a past or present leak unless confirmed in another section of this report. Moisture stains found are always possible to be from past leaks which have already seen repair. Monitoring of this location during a prolonged and heavy rainfall is recommended to further diagnose. Questioning of the seller may also be desired to better understand if any history of repairs made in this area is known. If found to be a current leak, evaluation and repair to the roof above or exterior is recommended.

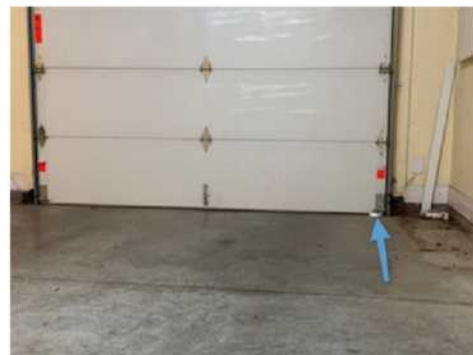
Weather-stripping is short at the the bottom of the door on the end as noted. Further improvement may be desired to reduce risk of moisture and/or insects/rodents from easily entering.

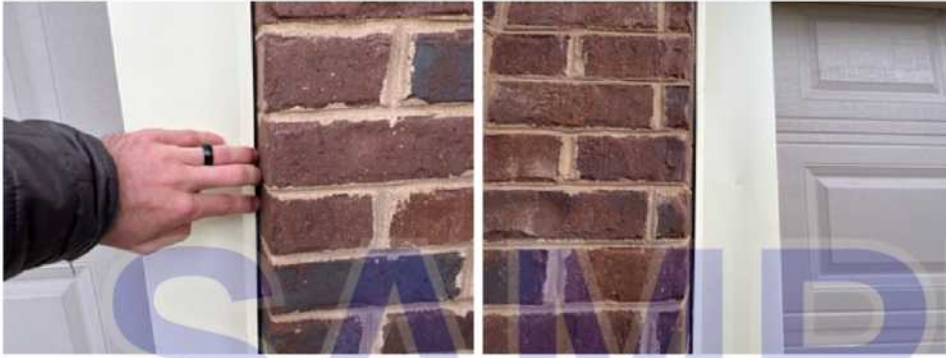
## 6.1.2 Garage Door

Gap at exterior trim is present where noted. Improvement is recommended to eliminate the gap and/or seal if needed to reduce the risk of moisture exposure to wood framing beyond.

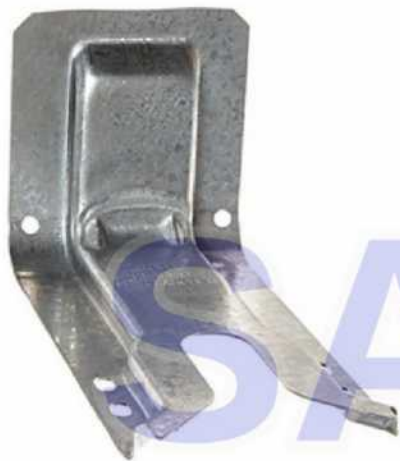
Back of stove is not secured to the floor with an anti-tip bracket. This bracket should be installed to reduce the risk of the stove tipping forward. Heavy food pulled out on an oven rack or children using the door as a stepping stool can put torque on the stove increasing the risk of it tipping forward. Recommend installation of an anti tip bracket for proper securing.

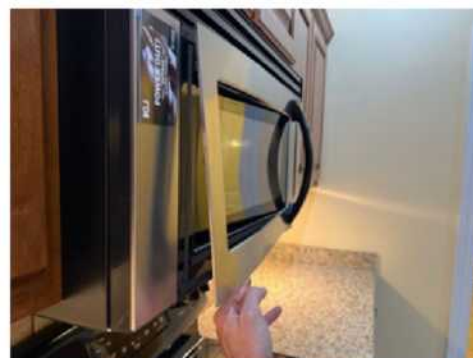
### 7.3.1 Microwave

Microwave door trim is loose where noted. Repair or replacement may be desired.

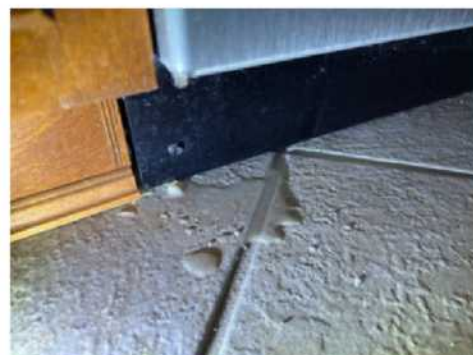
### 7.5.1 Dishwasher

Dishwasher has a leak when wash cycle is operated. Further evaluation and repair is recommended.

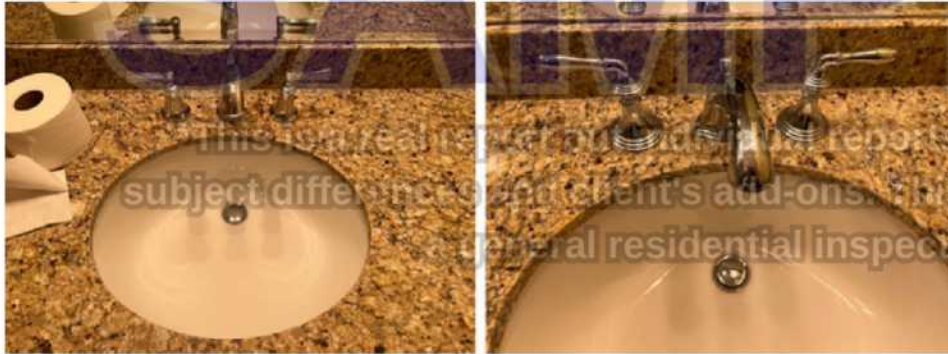
Drain stop is not properly operating or holding water in the sink as designed. Recommend further evaluation and repair as needed to return to an operable condition.

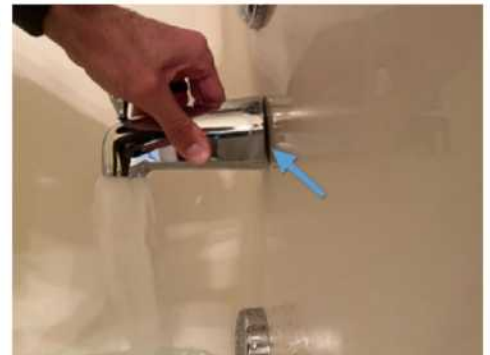
### 8.5.1 Tubs / Showers

Shower/tub fixtures are not well secured in the wall behind the surround. Loosely mounted fixtures are at a higher risk for leaks to develop in the plumbing supply lines as any movement can allow excessive stress to connections. If/when any plumbing renovations are planned or access is convenient, recommend further securing.

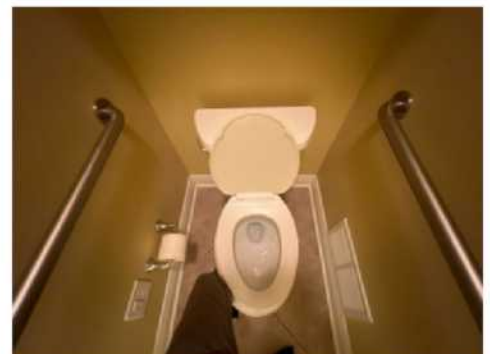
### 8.6.1 Toilet(s)

Toilet base is loose from the floor connection or allows some movement. If floor bolts are tight then shimming may be required to properly secure the toilet bowl/base. Any type of movement can allow connections to work loose and the wax ring can be at higher risk for failure. Repair is recommended to properly secure.

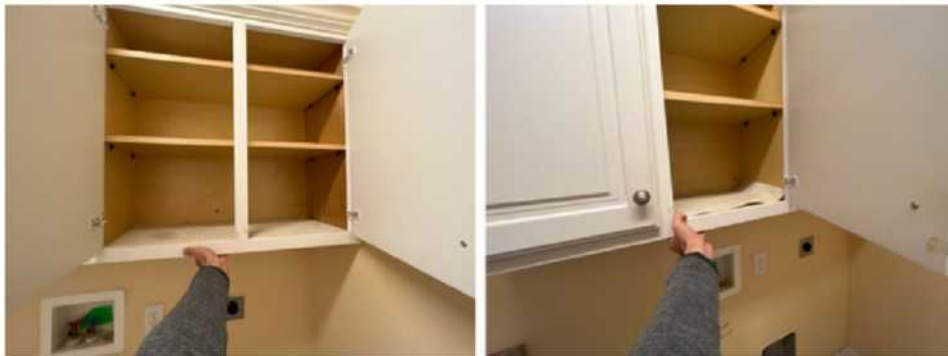
Wall cabinet where noted is currently loose from wall. Proper securing is recommended.

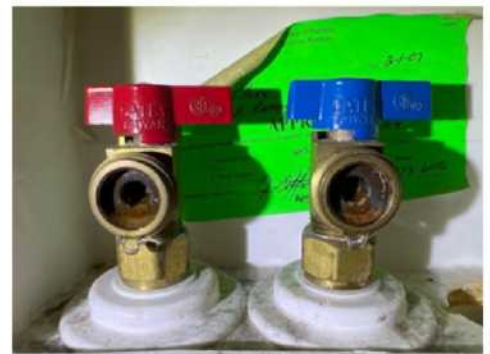
## 9.3.1 Hose Bibs / Outlet Box / Drain

Laundry hose bib valve is currently in the off position and leaking at the interior valve. Once a washing machine is reinstalled this leakage may become a non issue as the valve will remain in the open position. If not repaired prior to installation of a washing machine, this valve may leak worse once needed again in the future. Repair is recommended.

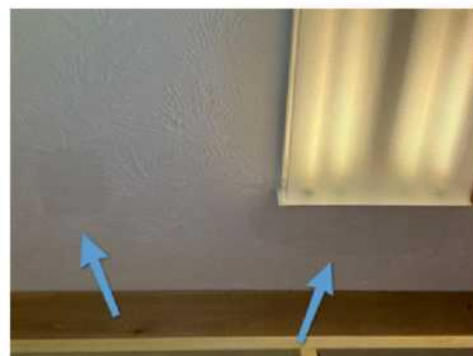
Patched/painted ceiling observed at noted locations. Noticeable repair locations may only be a cosmetic condition but it is recommended to question the seller about patch locations to gain the history and reason for the patching. It is always possible for these locations to be leaks of some kind that are just not leaking at time of this inspection or cracks that have not re-occurred.

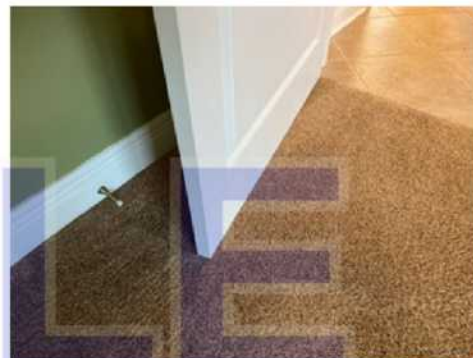
11.5.1 Doors, (Interior)

Door makes moderate contact with the floor where noted. Some adjustments or improvements to the door may be desired.

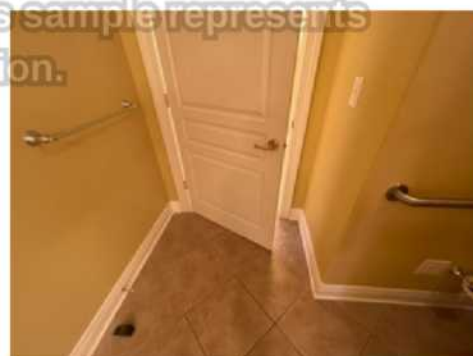
Door where noted closed by itself. It is suspected to not be installed plumb and/or need adjustments to the hinges. Recommend repair to ensure proper operation.

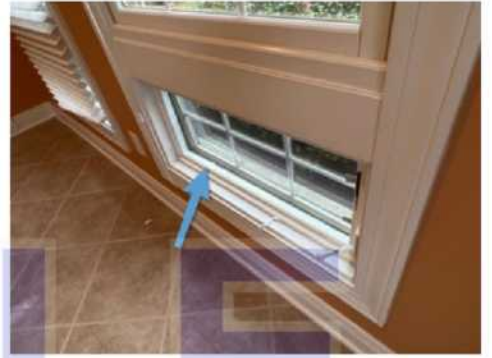
11.6.2 Windows

Window where noted is difficult to latch or will not latch with normal closing and pressure applied. Recommend further evaluation by an experienced window installer.
