CHC HOME INSPECTION  
(800) 975-0275  
info.chcinspection@gmail.com  
<https://www.chchomeinspection.com/>

## INSPECTION REPORT

Subject Address  
Lexington, KY

Inspector  
**James Sanders**  
KY Licensed Home Inspector, #276294  
(800) 975-0275  
admin@chcinsp.com

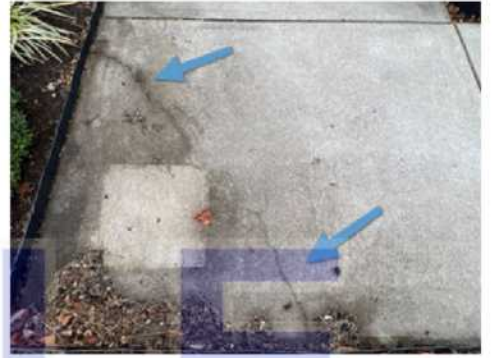
Random cracking is observed in the walkway. Cracking in concrete is a natural occurrence as the concrete dries/shrinks and typically will happen within every 10 to 15 feet of length. Other factors that may play a role in additional cracks is possible poor sub-grade preparation, limited reinforcing and/or poor water/cement ratio at time of placement. Monitoring of cracks is recommended as they can often allow differential settlement if aggregate separation occurs. These cracks do not affect the ability of the surface to function as a walkway but may result in uneven surfaces and/or tripping hazards. Improvement may be desired.

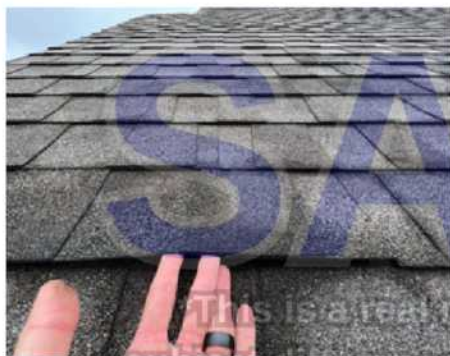
Existing wear of the shingle roof covering is consistent with a roof in the 15 to 20 years age of range. Moderate to significant granular loss can be found in random locations. Few shingles have lost adhesion to the lower courses. As the roof covering continues to age, further adhesion will be lost and roof will be at higher risk to wind damage.

Budgeting/planning for future replacement is recommended as roof coverings can be expensive to have replaced. This roof can be considered to be in the final stages of service life.

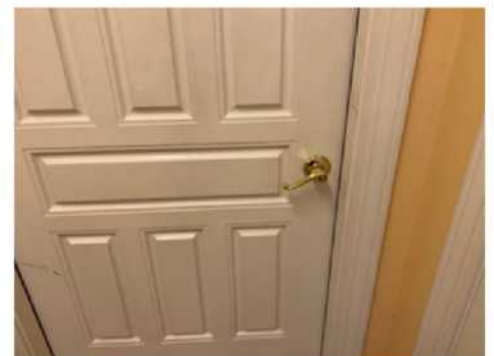
## 6.4.2 Separation Door

### THRESHOLD WEATHER-STRIPPING LOOSE/TORN

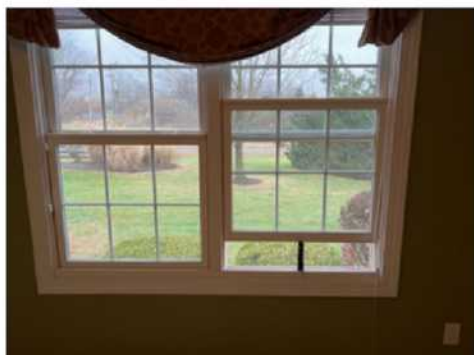
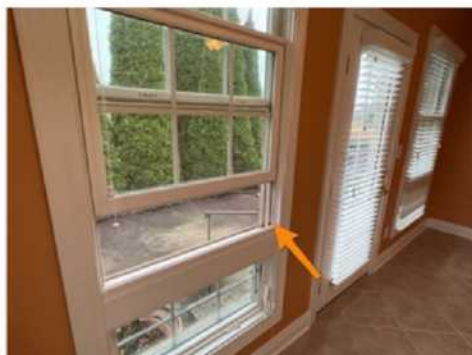
GUEST BEDROOM BACK WINDOW, BONUS ROOM RIGHT SIDE FRONT WINDOW

Window has broken or disconnected balances/springs. When one or both sides of the balances are not working the sash may have difficulty opening and may also not stay open when desired. Repair is recommended for proper operation to be restored.

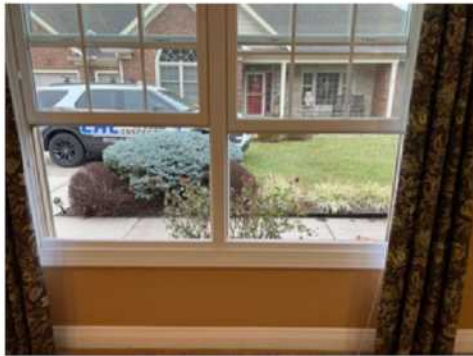
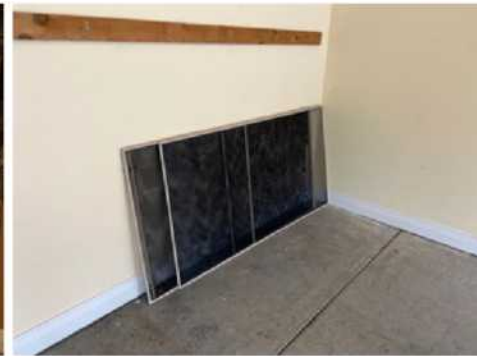
Window screen is missing at the noted window locations. Screens are not always desired, and are often removed for cleaning or various reasons. This is, however, a potential safety concern if children are living in the house. Recommend installation of screens as needed or desired.

\*Some screens are present in the garage.

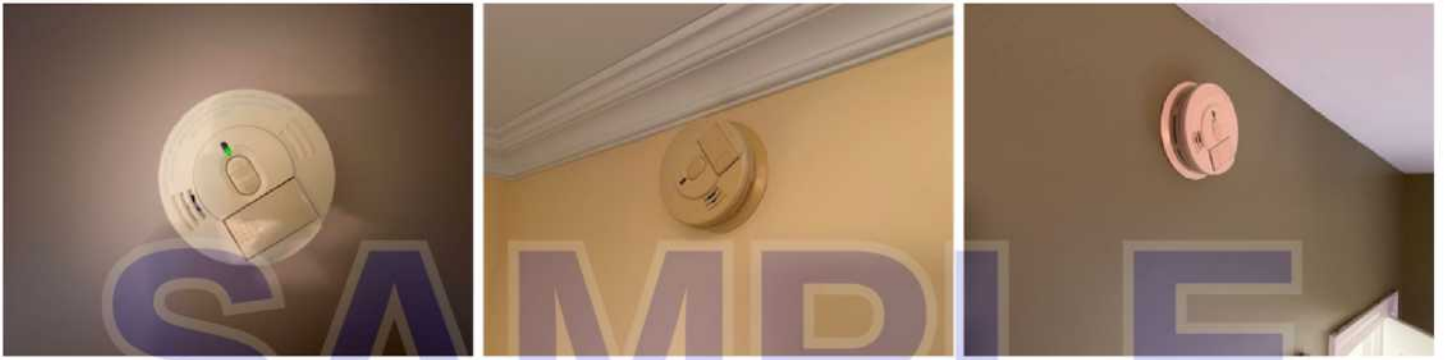
### 11.8.1 Smoke & Carbon Monoxide Detectors

#### SMOKE DETECTOR, (AT OR BEYOND 10 YEARS OF AGE)

Smoke detectors where noted, are at or beyond 10 years of age. Recommend replacement with new detectors and continued replacement every 10 consecutive years or sooner. When updating smoke detectors, remember that detectors should be located within each designated sleeping area of the house as well as central locations on each floor level. If the house has a large or wide floor plan, more than one centrally located detector is a good idea.

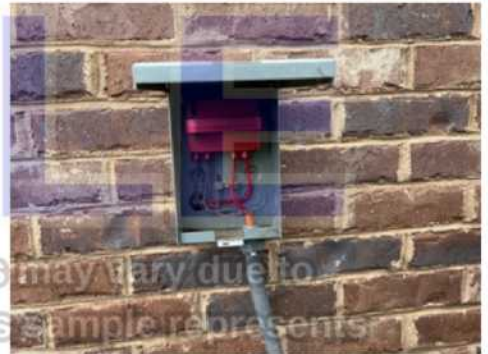
**DISCONNECT MISSING INSIDE  
COVER/GUARD**  
RIGHT SIDE OF BUILDING

Condensing unit electrical disconnect box is missing the interior cover which allows exposure of the wiring when opened. This presents a safety hazard unless a lock is kept on the box which is also not present at time of this inspection. Recommend installation of an interior cover or keeping the disconnect box locked to prevent unwanted access.

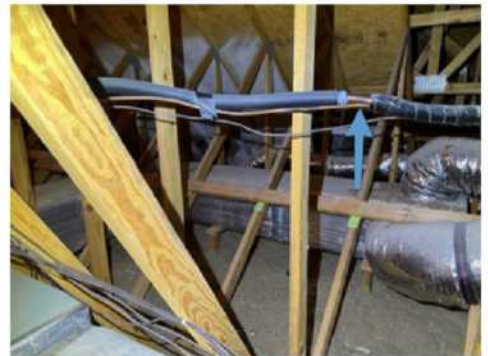
Torn or missing insulation is present where noted on the refrigerant line portion which is inside of the home. In areas which might contain higher levels of humidity such as attics, condensation can and often does form on the line which can drip and has the potential to create water damage to anything below. Recommend improvement to ensure the line is properly insulated.

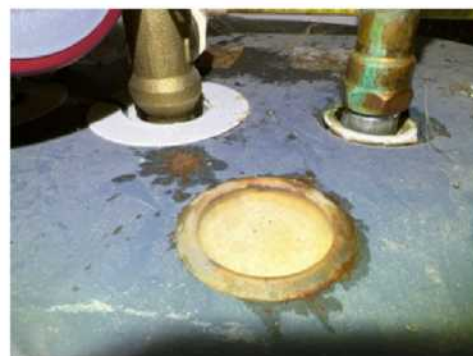
**RUSTING / CORROSION PRESENT**

Rusting / corrosion was observed at the water heater where noted.

This could be an indication the water heater is at or nearing the end of its service life or other issues are present. If water heater is older, replacement is encouraged.

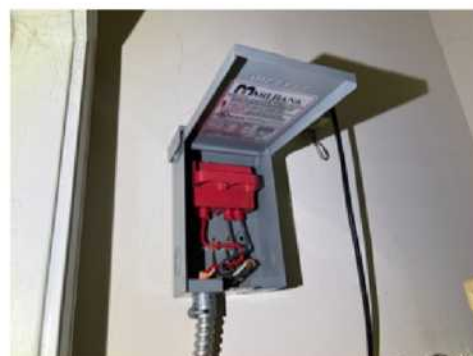
AT GARAGE WATER HEATER CLOSET

**DISCONNECT, (MISSING  
INSIDE COVER/GUARD)**

Disconnect where noted is missing the inside cover/guard plate. It is recommended to install this plate to ensure proper protection from wiring when using the disconnect. This plate also helps to prevent unwanted access in the event this disconnect is located in an easy to reach location.

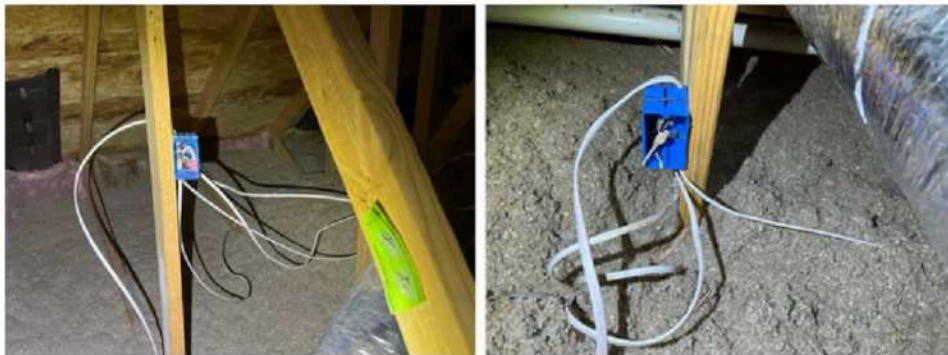
Junction box is present which does not have a cover plate installed. Full cover plates are recommended for proper containment of electrical connections.

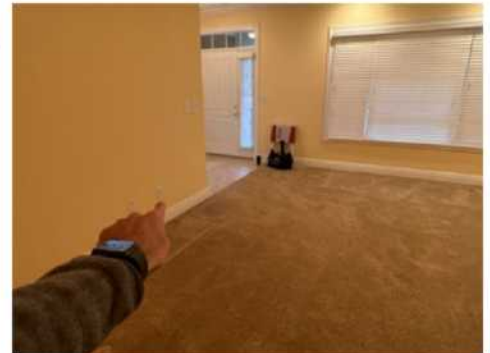
**RECEPTACLE/SWITCH, (LOOSE)**

Receptacle/switch where noted is loose at wall/outlet. Securing is recommended to ensure wire connections are not strained or potentially accessible.

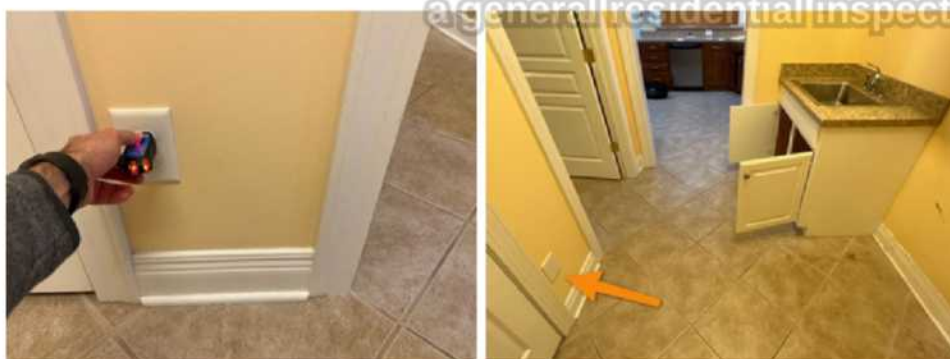
**RECEPTACLE, (NOT GFI PROTECTED)**

Receptacle is not GFI protected where noted per our receptacle tester. Even if this building may not have been required to have GFI protection at time of construction, this is a recommended safety upgrade for any receptacles near potential water sources or wet locations. Typically receptacles in bathrooms, kitchen, laundry, garages and at exterior locations should be GFI protected.

- If a GFI receptacle is present that does protect this circuit but is malfunctioning, then replacement of the malfunctioning receptacle will restore protection to the noted receptacles where protection could not be detected.

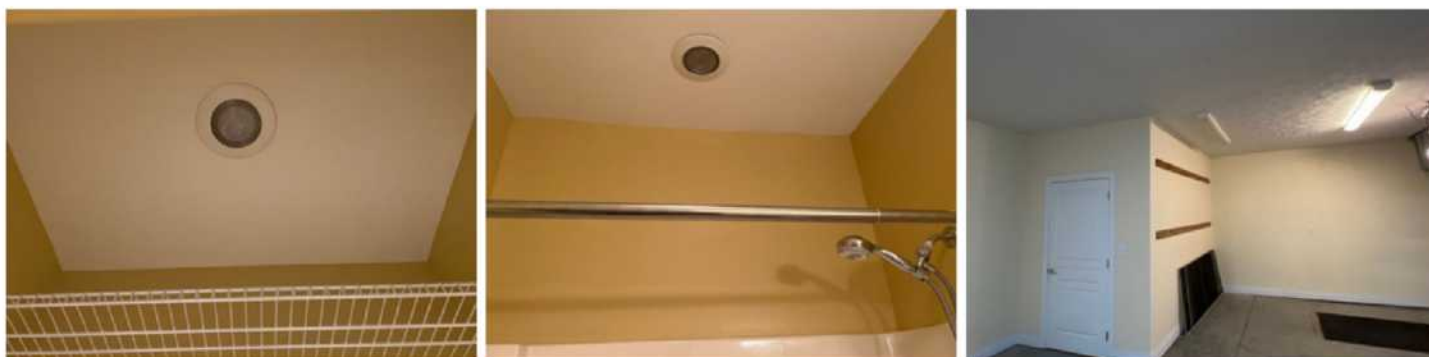
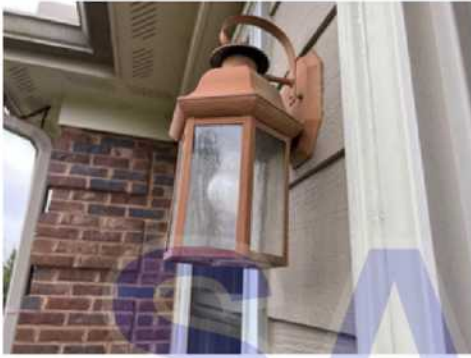
MASTER BATHROOM SMALLER CLOSET, HALL BATHROOM SHOWER LIGHT, BACK GARAGE LIGHT, BONUS ROOM EXTERIOR LIGHT

Fixture is not operating where noted. Fixtures are not opened up to determine if bulbs are bad at time of the inspection. If a new bulb does not remedy this issue, then further evaluation is recommended by a licensed electrician to correct.

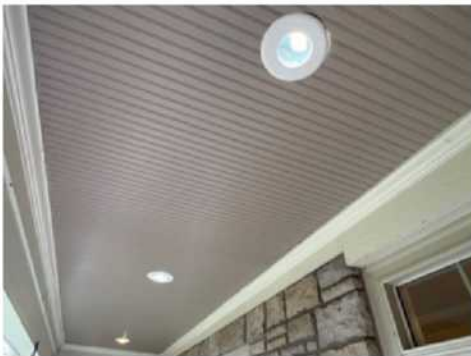
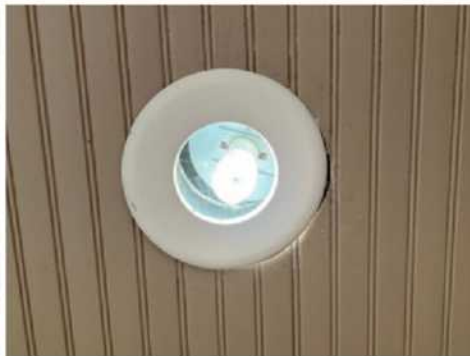
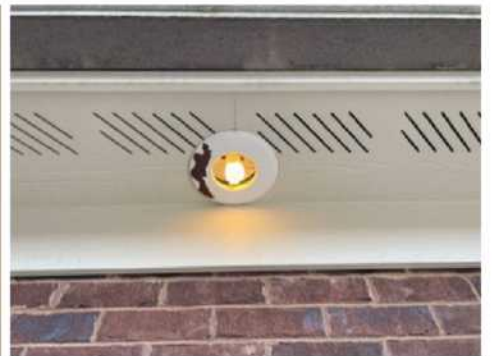
**FIXTURE, (MISSING GLOBE/GLASS)**

Light fixture is missing globe/glass where noted. Recommend installation for proper protection and containment of bulbs.
